# **Vladimir Putin's Russian Government Inquiry into the Crash of The Polish Air Force One in Smolensk, Russia, April 10, 2010**

**Polish Parliamentary Committee for the investigation of  
the Tu-154M crash in Smolensk, Russia on April 10<sup>th</sup>, 2010  
under the chairmanship of Antoni Macierewicz**

**Study prepared by Kazimierz Nowaczyk, Ph.D.**

**European Parliament, Brussels, March 2015**

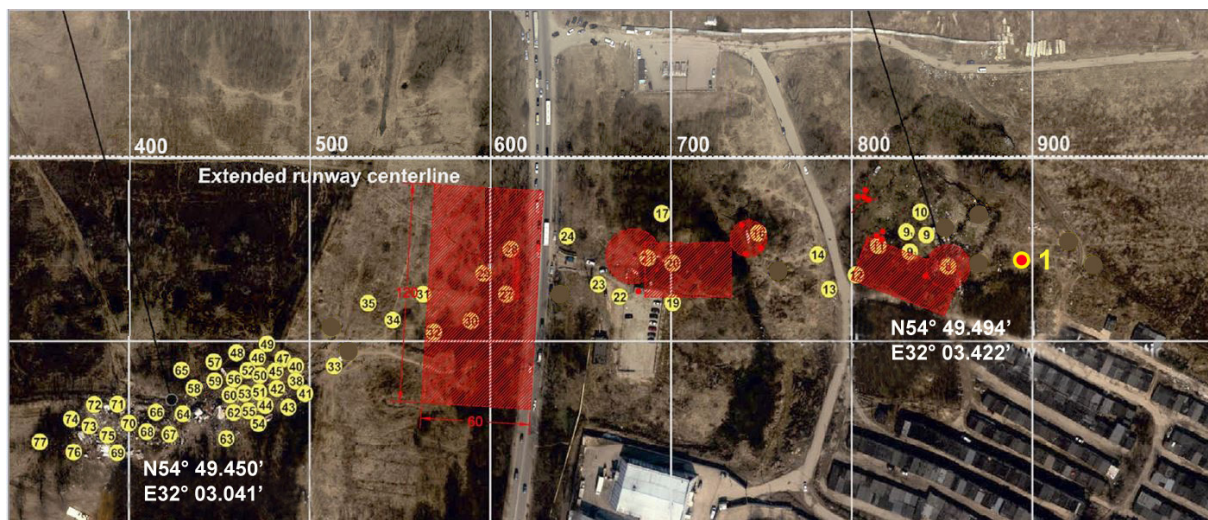
**Figure 10.** Russian prosecutors' debris localization (red boxes) from 10 and 11 April 2010 over air photo from the IAC report (M. Dabrowski, K. Nowaczyk).

An illustrative example of such a course of the disaster was an aerial view photo of the crash scene taken on 12/04/2010 marking only selected fragments of found pieces of the wreckage debris. Three years after the disaster, journalists published the hidden protocols prosecutors of the Russian Federation dated 10 and 11 April describing the airplane pieces found few hundred meters before main crash scene, where the plane was still in the air. Their quantity and origin not only of the damaged wing (IAC report), but also of the fuselage, deny these posed in sections 3.1.5 and 3.1.6. Differences between IAC report (yellow dots) and description prosecutors (red boxes) are shown in the Figure 10.

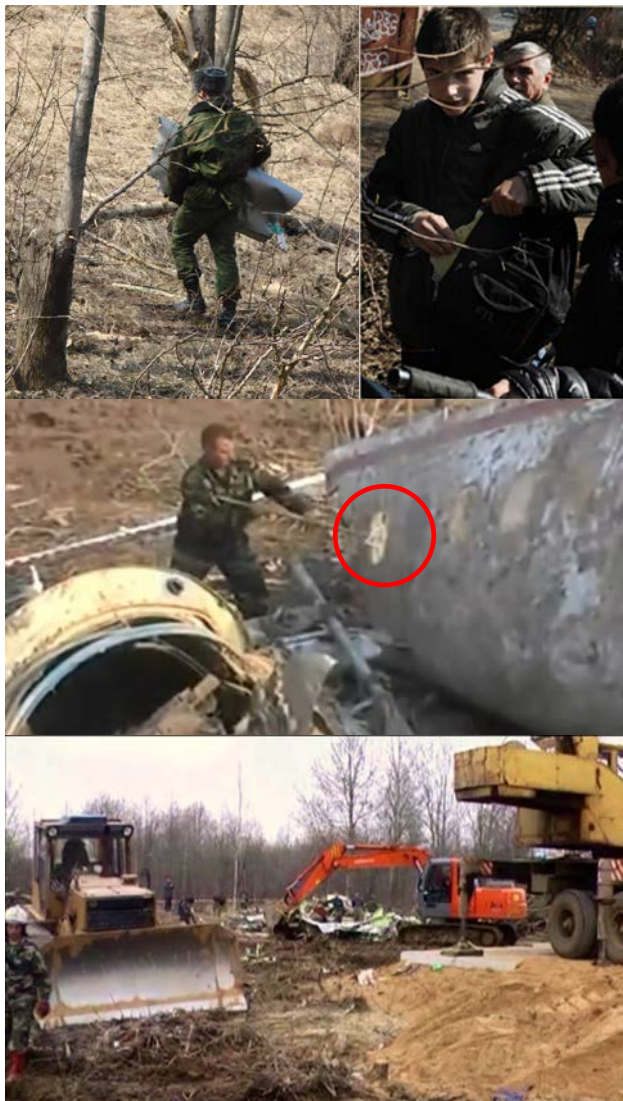
**Figure 12.** Examples from crash site from first three days, April 10-13. Appendix VI.

windows in the fuselage were broken immediately, large sections of the airplane were cut into smaller parts, cables were cut and pulled out, heavy sections were deformed and damaged further by being dragged by an excavator and other heavy machinery, large areas of the crash site with smaller debris were bulldozed and finally some parts of the crash scene were quickly covered up with fresh soil or concrete. Crash deformation of aircraft tail has been ‘repaired’<sup>45</sup> even before it was moved to its final storage site. In the end, larger airplane parts were transported to a nearby airport concrete pavement and left for many months without any protection from weather conditions and onlookers (Fig. 13). Several tons of small parts were piled up like trash in a nearby barn, without any order or protection. After many requests from the Polish side, the larger wreckage parts were eventually fenced off and covered by a tarp. Later, a plywood structure was built over the

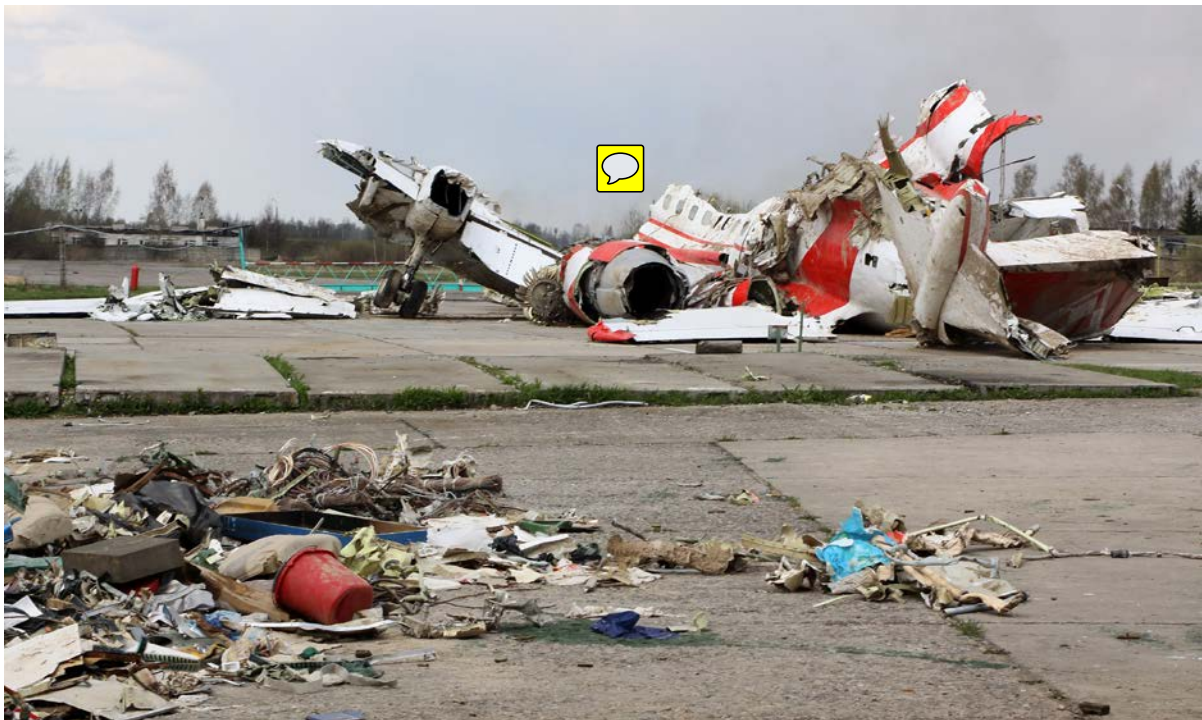
**Figure 13.** Largest airplane parts on the concrete pavement after transportation from crash site.

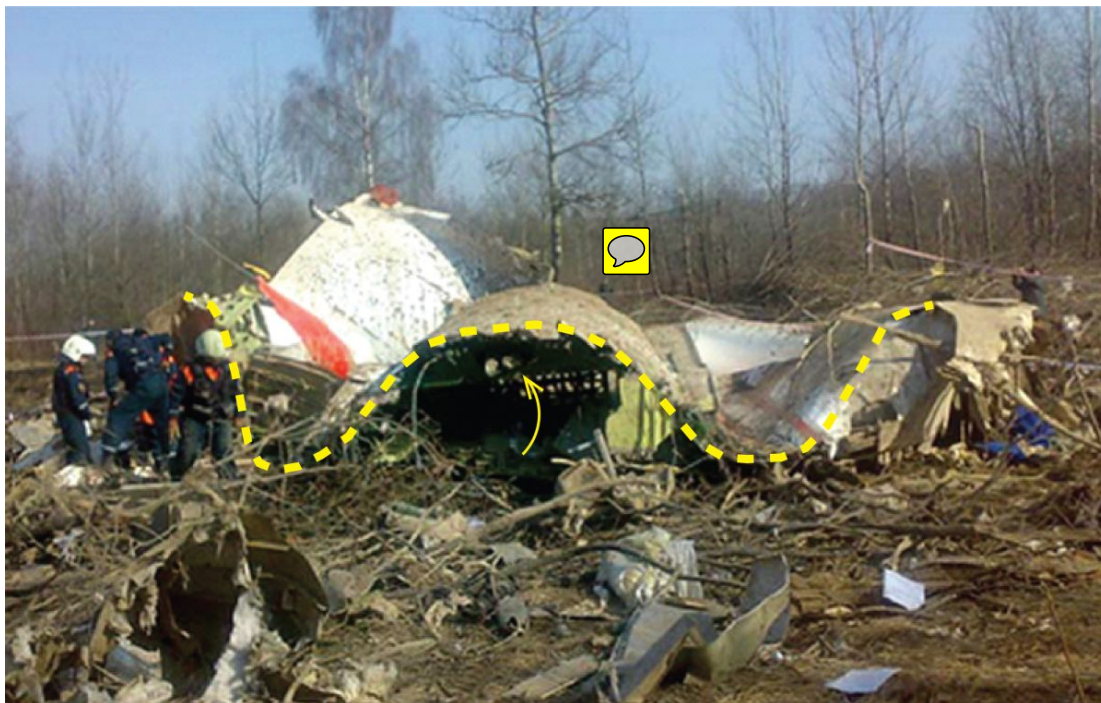
**Figure 14.** A part of the fuselage inverted and opened up (yellow line and arrow). Appendix VIII.

Finally, a self-evident photograph (Fig. 14) showing a large part of the fuselage at the crash site proves beyond any reasonable doubt that the fuselage must have opened midair and fallen to the ground inverted, with both side walls of the fuselage bent outwards. Consequently, the next day after the crash, both walls of the fuselage were cut off and moved away. This is clearly visible in the aerial view picture of the crash site presented in the IAC report (Fig. 15).

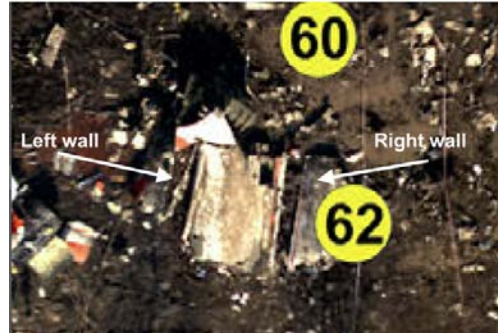
**Figure 15.** Left and right walls cut off from fuselage on 04.11.2010. Separated walls (white arrows) on air photo in IAC report.

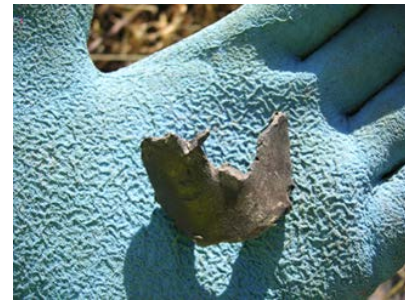
On top of the hidden Russian Federation prosecutors' protocols dated 10 and 11 April described above in part 4.1, six months after the crash a team of Polish archeologists was finally allowed to examine the crash site. The Polish experts found 10,000 small fragments on the surface and identified another 20,000 fragments of metal hidden in the soil up to 20 cm deep using metal detectors operating within the 20cm range. Using several drills, they confirmed that the location of every small metal fragment was accompanied on average by another six non-metal fragments (total estimated number 60,000). Some metal fragments had been exposed to high temperatures (example in Fig. 18).

**Figure18.** Example of a burned metal piece of debris found in front of main crash site. Appendix XI.

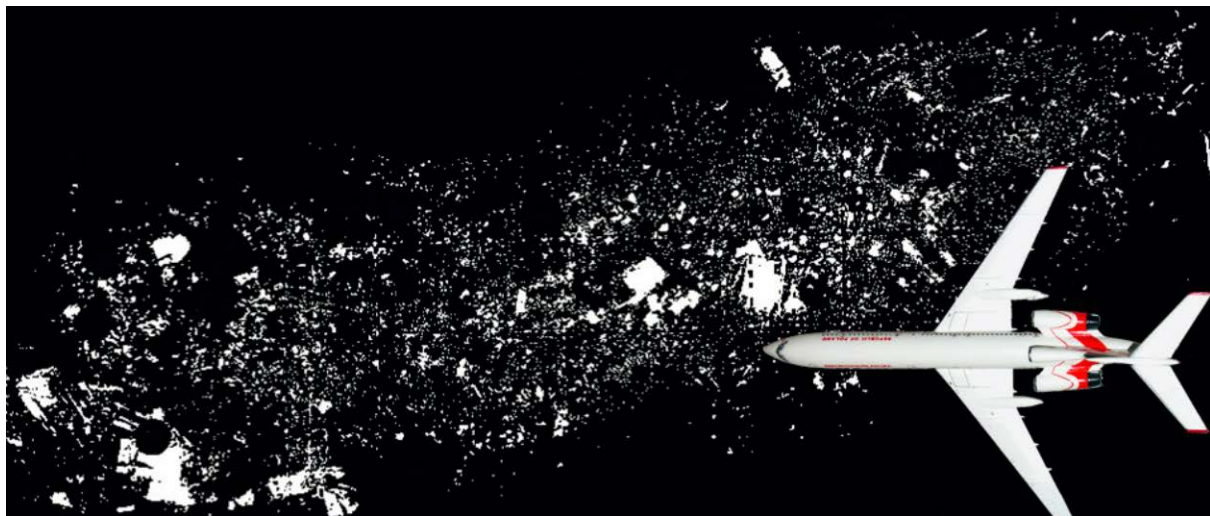
**Figure19.** Map of debris found at the main crash site, prepared for the Polish Archeologists' Report (Appendix XI). The airplane profile is in scale 1:1 to the ground area. (K. Nowaczyk)

The Polish team was limited in its search only to the area of aircraft contact with the ground, but the number of visible debris on map prepared for the Polish Archeologists' Report (Fig. 19) and listed in Table 2 is incomparable to famous air catastrophes caused by explosions.

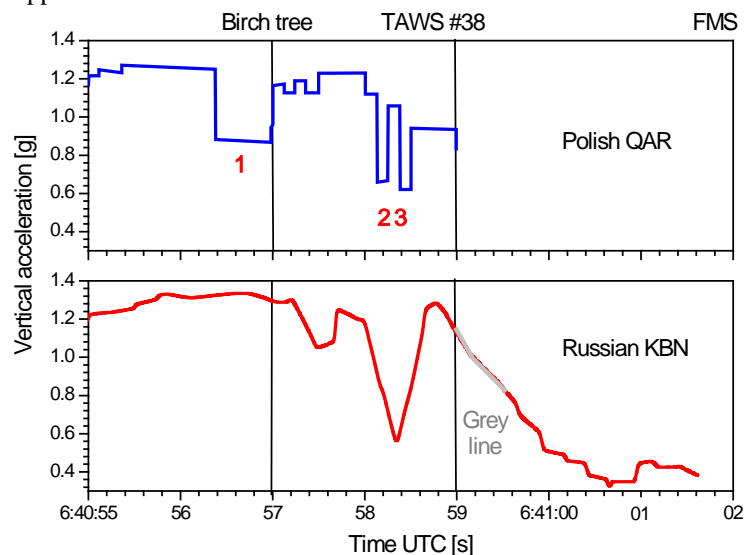
Data recovered from some of the aircraft's recording devices have been subject to arbitrary alterations and some of the data from FMS<sup>65</sup> and TAWS logs have not been included in the Russian analysis. Figure 21 shows a vertical acceleration chart from the Polish QAR recorder and IAC report. QAR indicates three peaks (points 1, 2, 3) occurring in a very fast succession, in the order of one tenth of a second, before TAWS #38 and around 200 m before the crash site. It should be noted that the first of these strong shocks occurred about 50-70 meters before the birch tree location. These strong acceleration changes were caused by a downward-acting force, but they were neither explained nor accounted for in the Russian Report. The **grey area** on graphs in Figures 21 and 22, indicates a location where the Russian analytic program WinArm32 used by IAC removed "problematic" data points. Such locations are automatically selected and marked in gray by WinArm32.

**Figure 21.** Vertical acceleration from the Polish QAR recorder and Russian report. Three peaks (points 1, 2, 3) occurring in very fast succession, in the order of one tenth of a second, not explained in IAC report. (Appendix X)

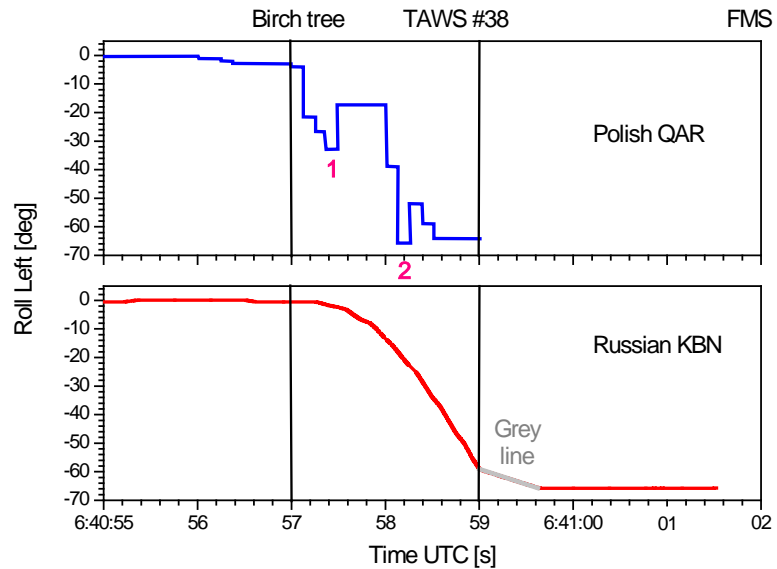
Figure 22 shows an example of significant differences between values registered by the Russian KBN recorder and the Polish QAR recorder. Both recorders

**Figure 22.** Recorded Roll Left angle from parallel recorders connected to some sensors. Graph prepared based on data from the Russian IAC report and ATM PP expert opinion. Appendix X.

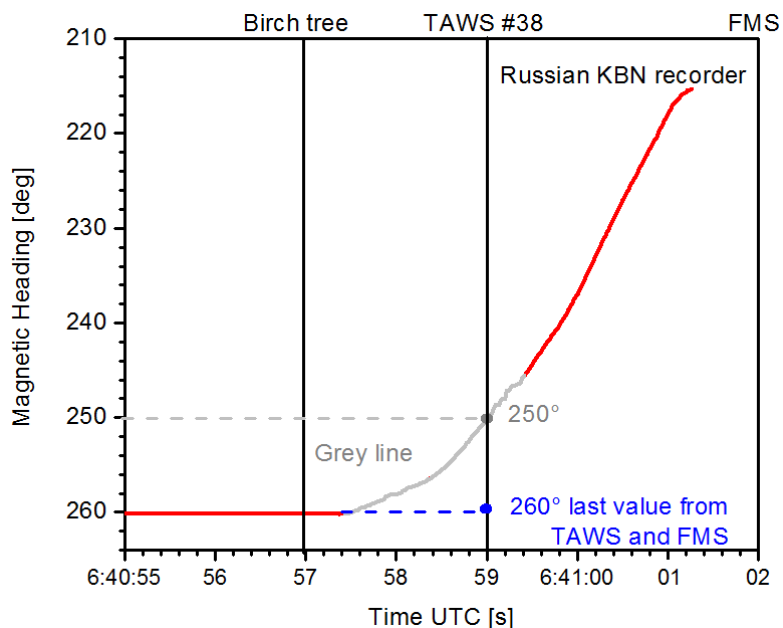
According to FMS data, the last magnetic heading value recorded was 260 degrees (taking into account the magnetic declination, Figure 23). The fact that this is the last available data point is confirmed by the information recorded in the FMS memory<sup>66</sup>. But in the Russian report, in the same point the value is 250 degrees. What is then the source of data as to the aircraft's magnetic heading after the point of 260, considering that both FMS and FDR receive their inputs from the same instrument?

**Figure 23.** Magnetic Heading recorded by TAWS #38, FMS (blue point) and presented in the IAC report (red line). Appendix X

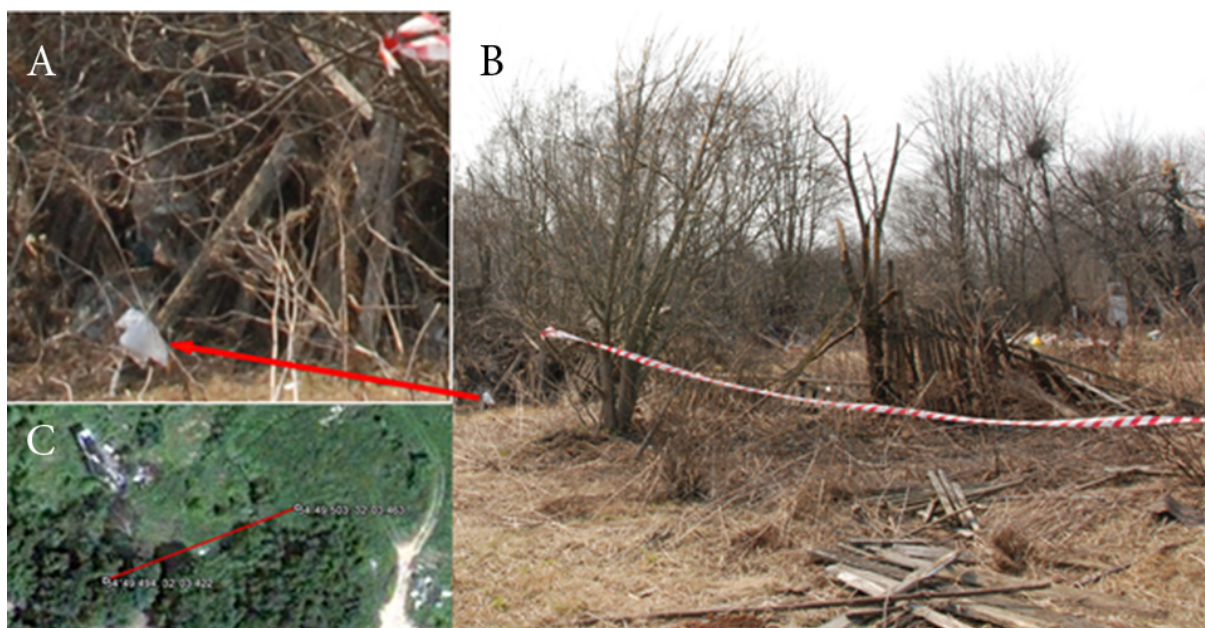
The Independent Investigation found ground evidence of this event. Fig. 26 shows aircraft wing debris found about 25m 'up range', or before, the birch tree. The Russian Report had claimed the birch tree to be the point the aircraft first sustained impact damage (by hitting the tree). Earlier, the official Polish crash investigation documented other debris a little further away at ground coordinates N54 ° 49.503/E 32.03.463, or about 40 m up range from the birch tree [Polish prosecutors report E-che-90/12]. Still other wing debris, found 'down range' at a distances of between 40-150m from the point of the in-flight explosion, evidenced the subsequent break-up of the wing (see Part C Fig-26).

Figure 26. Aircraft wing debris found before, the birch tree.

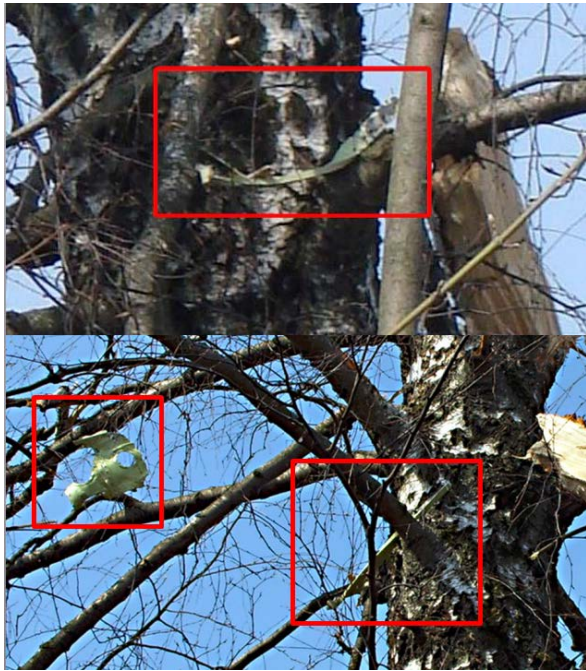
In terms of the 'target birch tree' itself, the Independent Investigation closely examined a photo of Russian origin which shows flotsam (wing) debris which had landed, and was caught, on the tree. It concludes that this evidences a mid-air wing explosion event before the aircraft reached the tree's position and that this debris fell onto the tree as a result. [see Fig.27 flotsam] Under the Russian scenario, the collision with the tree would have occurred at an aircraft speed of 75 meters-per-second and left this debris hanging on it, something the Independent Investigation rejects as 'physically impossible'.

**Figure 27** Fragments of left wing hanging on birch tree after collision at 270 km/h

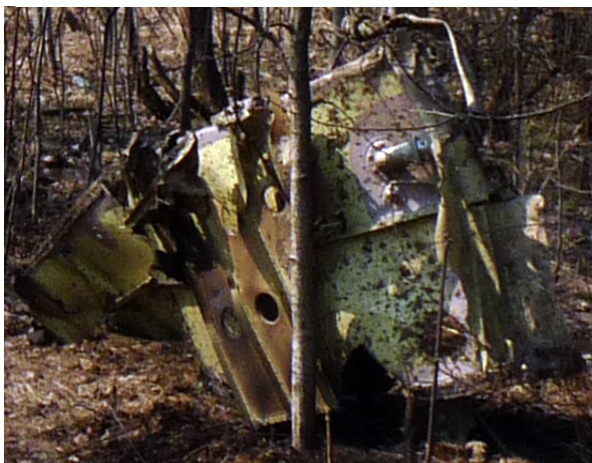
**Figure 28.** The aircraft's center wing box around 80 m in front of main center wing position on the crash site. On the surface visible signs of the fire.

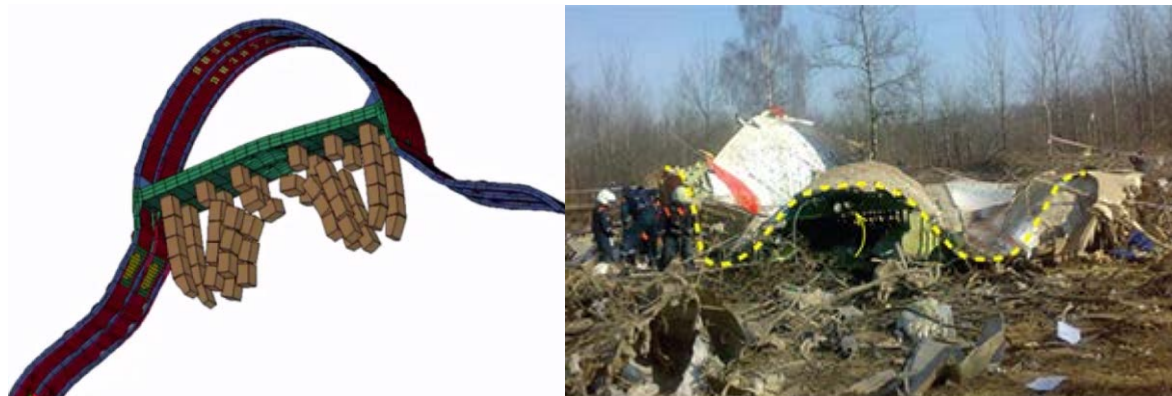
The plane wreckage, debris shape and state of the bodies point to explosion (G. Szuladzinski, W. Binienda). The photograph and frame from simulation in Fig. 29 shows a portion of the mid-rear of the aircraft at the main crash site. This section of the fuselage is inverted (upside-down), the position in which the Russian report states it crashed. The figure, also showing the section in the same inverted position, shows the intact curved bottom of the fuselage with the floor also intact. The upper part of the fuselage, including the walls and roof, are ripped open and bent outward. The Independent investigation concludes this evidence squarely indicates the mid-air explosion in the fuselage was the primary event that brought the aircraft down:

**Figure 29.** Left - Internal explosion in fuselage - dr. Szuladzinski LS-Dyna simulation. Right - A part of the fuselage inverted and opened up (yellow line and arrow).

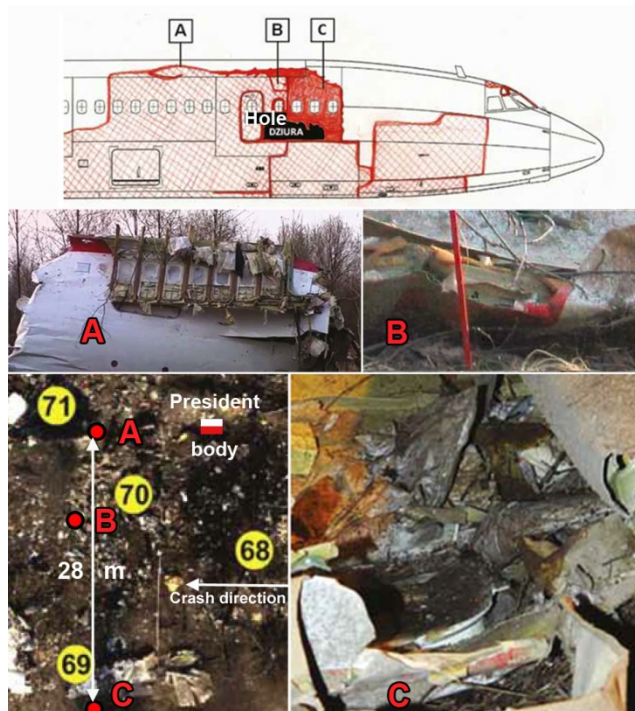
**Figure 30.** Location of parts from presidential suite at the main crash site, at distance 28 m transverse to the direction of impact (points A and C). Signs of high temperature and high pressure inside the presidential suite (part C).
