## **Urban legends for the European Parliament**

In March 2015 the Polish “Parliamentary Committee for Investigation of the Tu-154M Crash” presented a paper on the causes of the 2010 crash of the Polish presidential aircraft in Smolensk to the members of the European Parliament. It's utterly astonishing that the paper refers to the Russian IAC (MAK) report, disregarding the official report prepared independently by the Polish state commission and published in July 2011.

## **Errors, misconceptions, urban legends and lies in the Committee's paper**

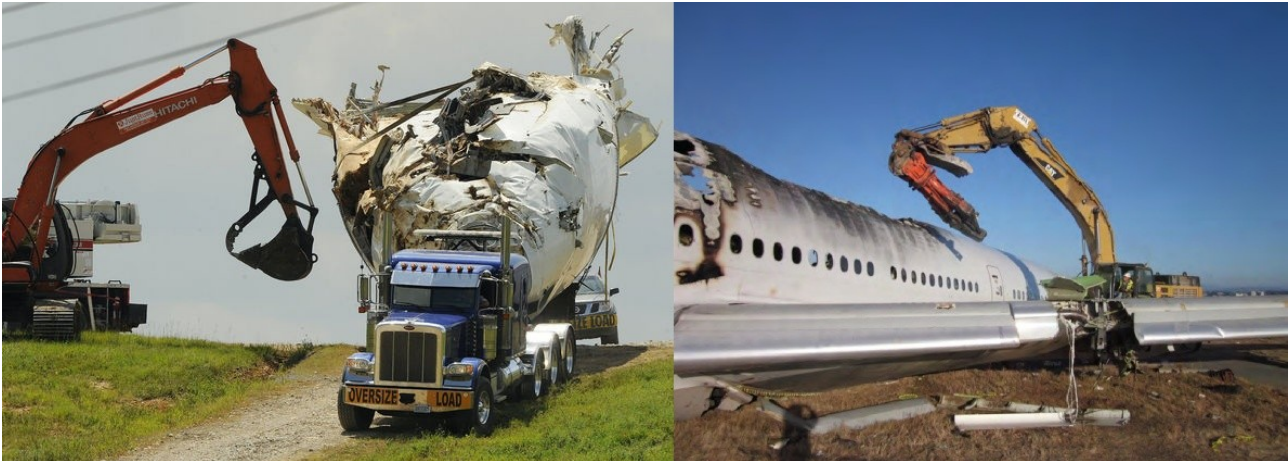
Cutting of large wreckage parts before removal from the crash site is often required and is a normal procedure – ask AAIB, BEA, BFU, NTSB or other aviation accident investigation agency. Wreckage condition has been documented (photographed) prior to removal.

Fig 1: Heavy equipment used to remove aircraft wreckage. Left: Birmingham-Shuttlesworth, Alabama UPS 1354 crash (Source: al.com), Right: San Francisco, California Asiana 214 crash (Source: nycaviation.com)

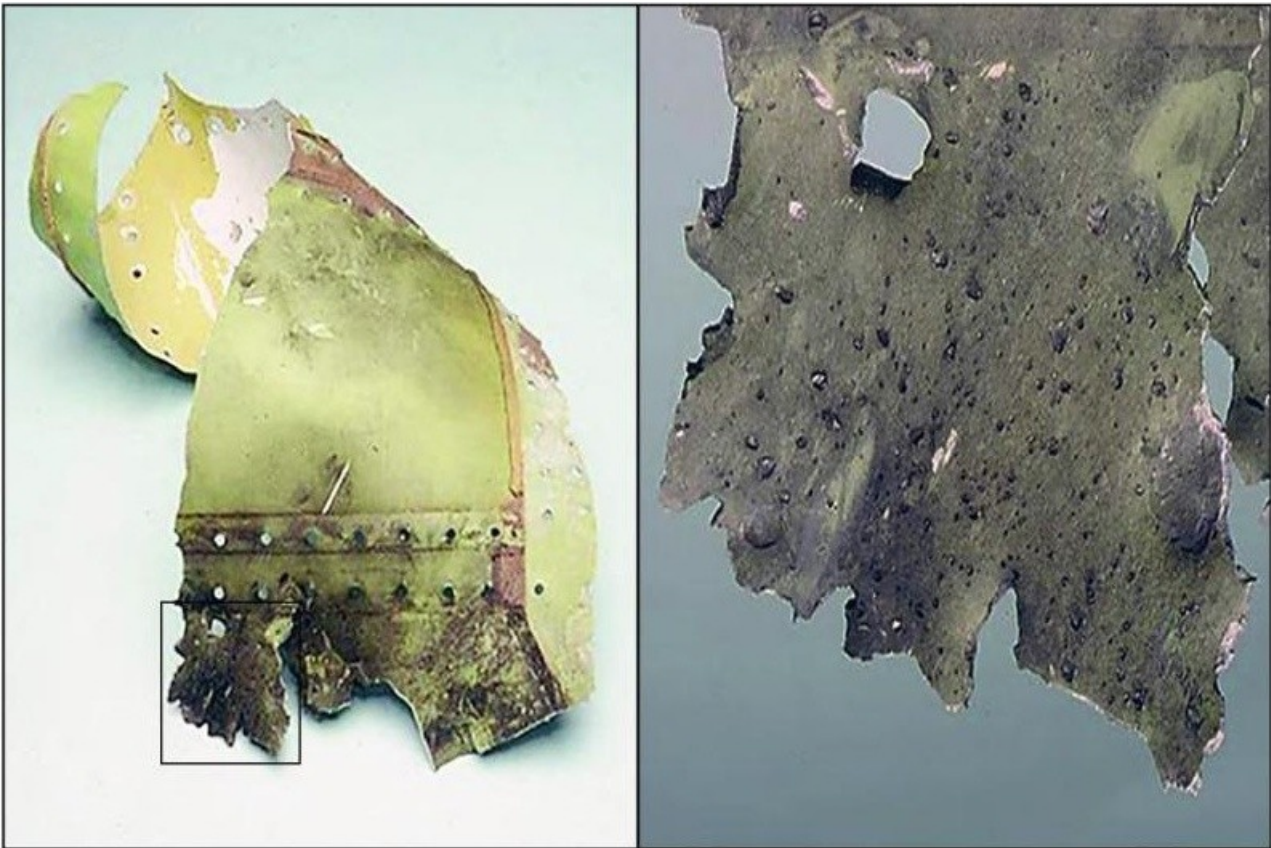
There's no evidence of inflight explosion at all. Airframe fragments found outside areas of post-crash fire were not sooted, no debris exhibit marks typical to explosion, like sooting, petalling or pitting. No debris from inside the fuselage were found before ground scars, so the fuselage was destroyed on impact with ground.

Fig 2: A concentration of staining and microcraters with some gas wash near the tip of a curl from a petaled hole torn in an aircraft fuselage by explosion. No such marks have been found in Smolensk. (Source: *Forensic Investigation of Explosions*, CRC Press, © J. Garstang)

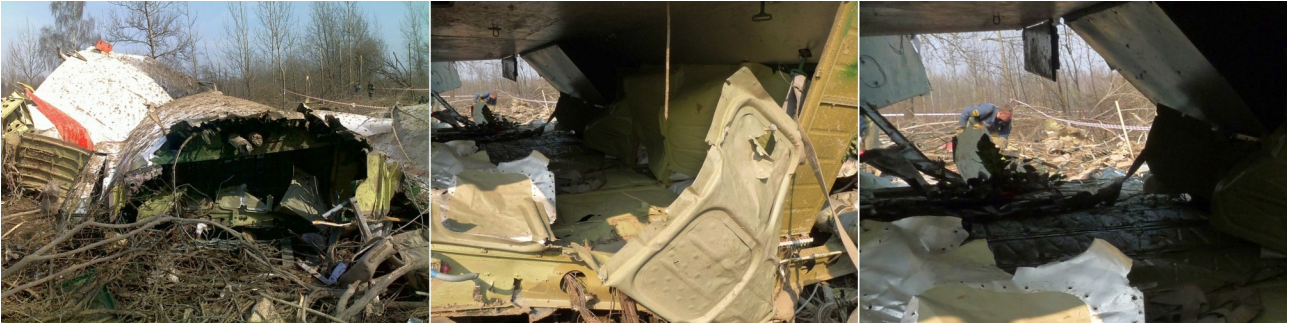
This assumption is just silly. Condition of the wreckage was documented on photographs. What's important, the cargo hold ceiling visible in this part of wreckage, which was also the cabin floor, can be seen perfectly flat, what would not be the case after an explosion in the fuselage.

*Fig 3: A look inside the cargo hold reveals perfectly flat ceiling (now at bottom) being also the cabin floor, that would be buckled or destroyed in case of explosion in the fuselage.*

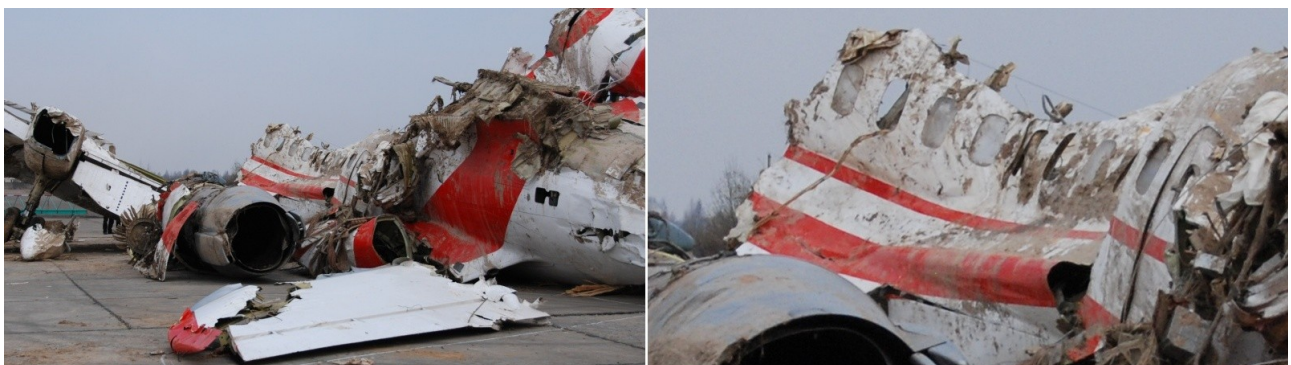
It's a lie. Most of window panes can be seen intact on photographs from the storage site on the Smolensk Severny aerodrome. A few were broken to hoist large fuselage parts from the crash site (a rope remaining in a broken window can be seen on photographs from the storage site).

*Fig 4: A rope used to hoist large fuselage part can be seen remaining in a broken window on a photograph from the storage site*

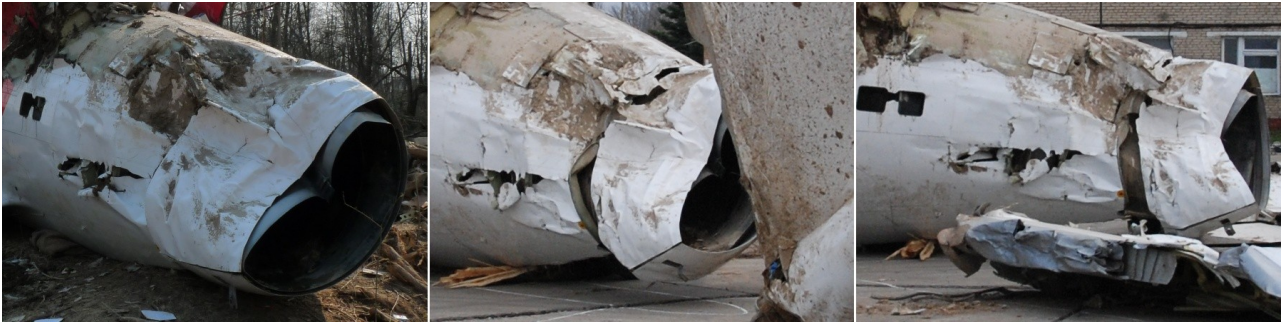
It's an urban legend. Deformed engine #2 exhaust nozzle can be seen on photographs from the storage site on the Smolensk Severny aerodrome.

*Fig 5: An urban legend presented to the European Parliament: “deformation of aircraft tail has been 'repaired' even before it was moved to storage site”. Deformed engine #2 exhaust nozzle seen on photos from the crash site (left) and storage site on the Smolensk Severny aerodrome*

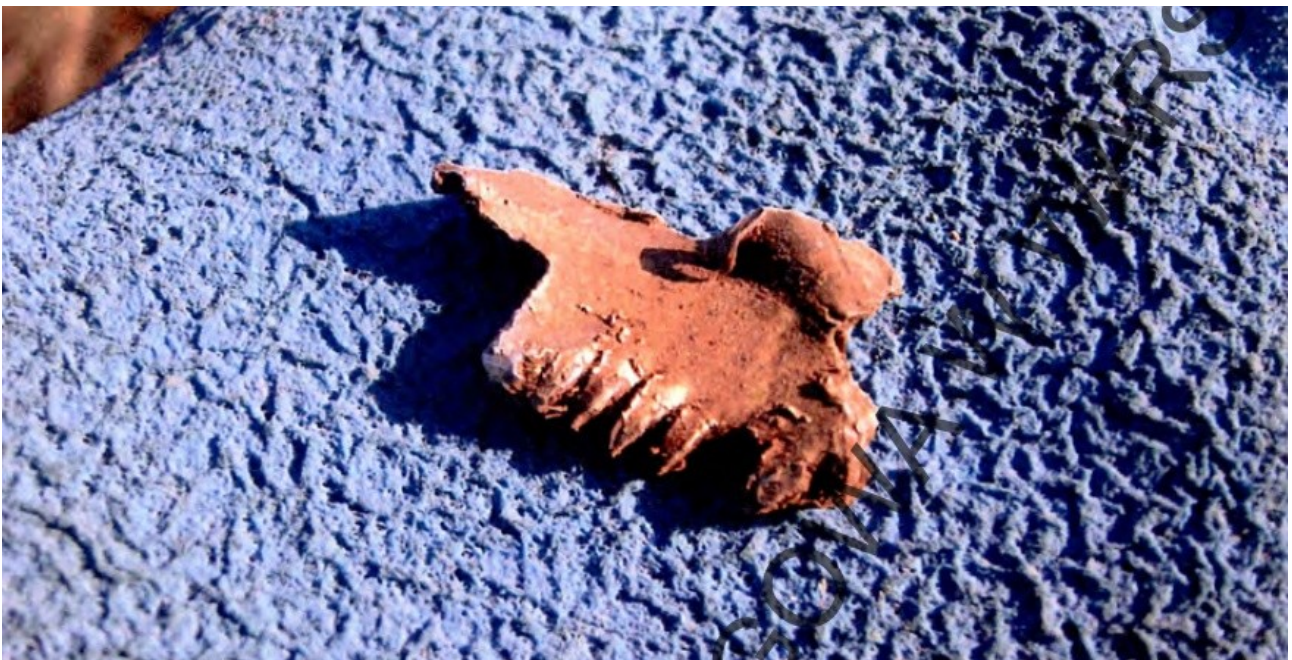
Smolensk Archeologists' report says: "Perhaps they were burned/sooted due to passing through hot turbines". Indeed, marks left by tips of rotating turbine blades can be seen on a photo in the report.

*Fig 6: Marks left by tips of rotating turbine blades on a small metal fragment suggest it has been ingested by one of plane's engines – photo from the Archeologists' Report*

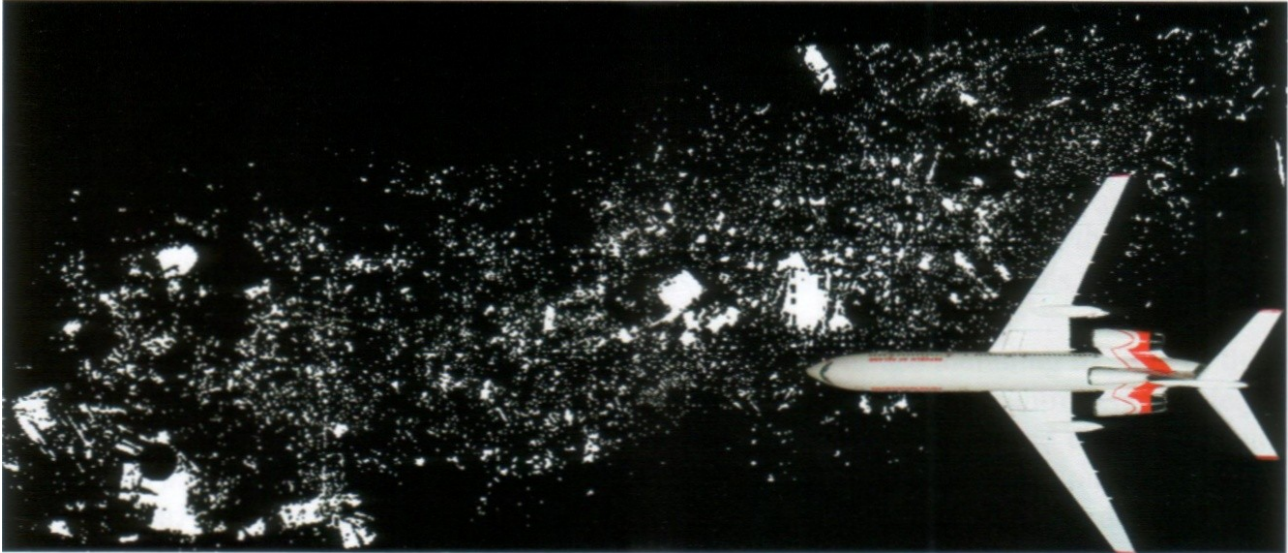
Elongated shape of the debris field is consistent with shallow impact with ground. Besides, the debris field that the paper refers to starts with the first ground impact point.

*Fig 7: Elongated shape of the main debris field is consistent with shallow impact with ground. Narrow width contradicts the explosion theory. Point of the first impact is just outside the top-right corner of the picture.*

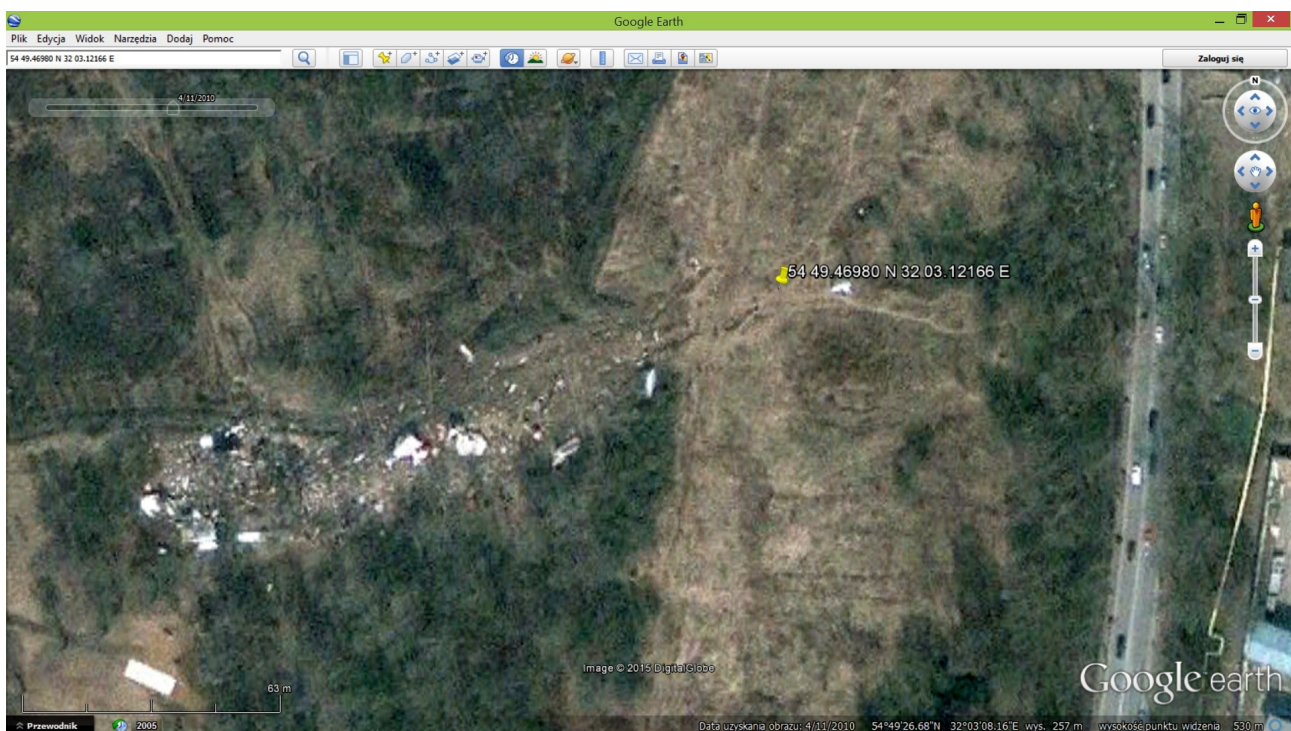
The FMS data contains last recorded coordinates from three onboard GPS receivers. All of them point exactly to ground scars marking first impact with the ground – and this is where power was lost due to disintegration of the fuselage. Everyone can check it just by entering these coordinates into the Google Earth search field.

*Fig 8: Last GPS coordinates recorded by FMS computer match exactly the point of ground impact*

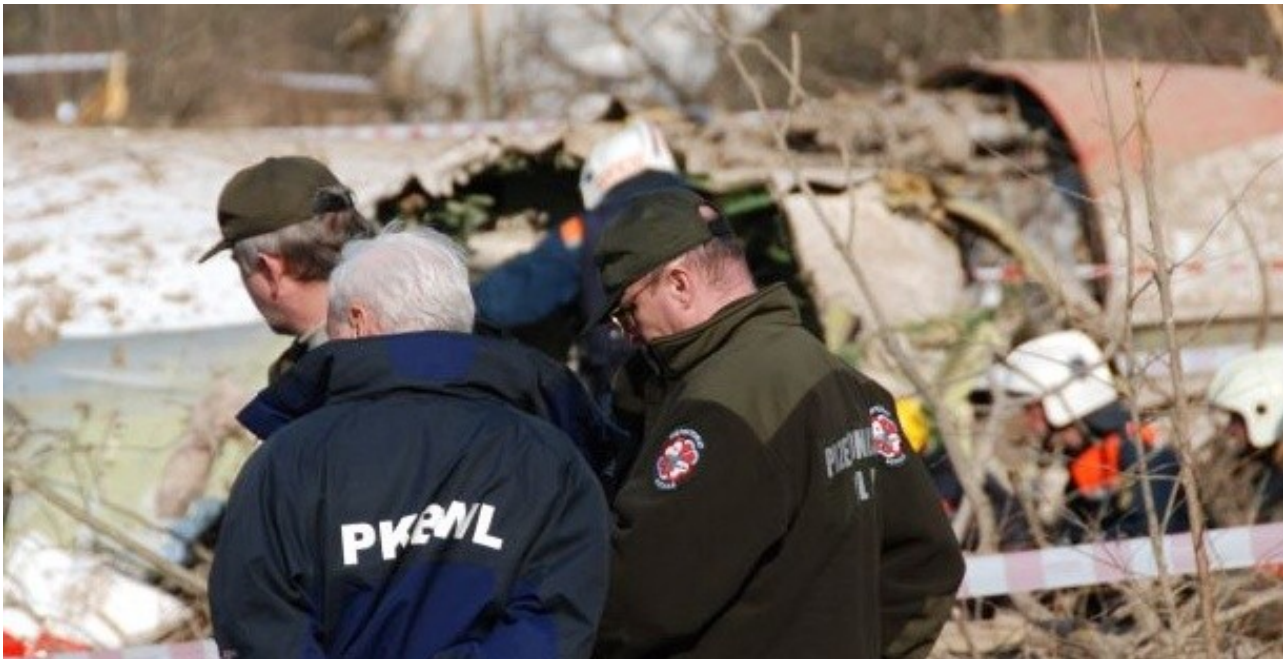
They examined the crash site and wreckage, taking over 1500 photographs.

*Fig 9: Polish civilian and military investigators on the crash site in Smolensk*

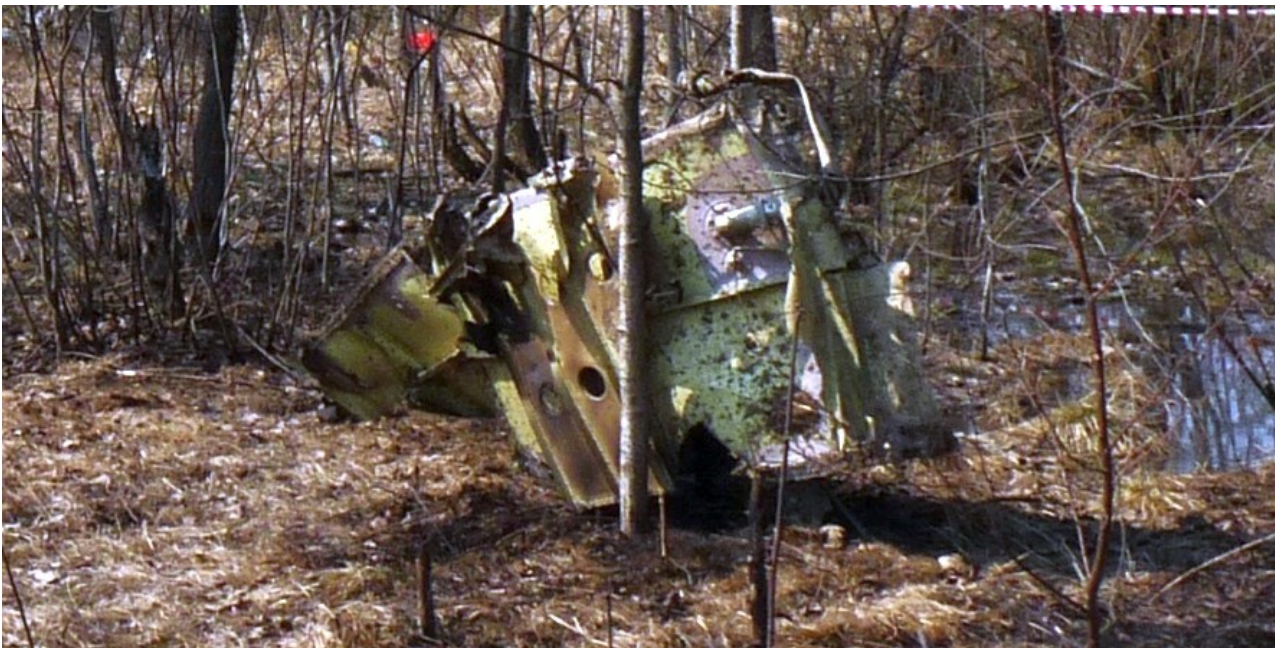
Sooting visible on the structure was caused by the post-impact fire, that also charred the grass below it. By the way, it's a fragment of wing spar, not a wing box.

*Fig 10: Soot on the fragment of wing spar was not left by explosion, but by small post-crash fire that also burnt the grass*

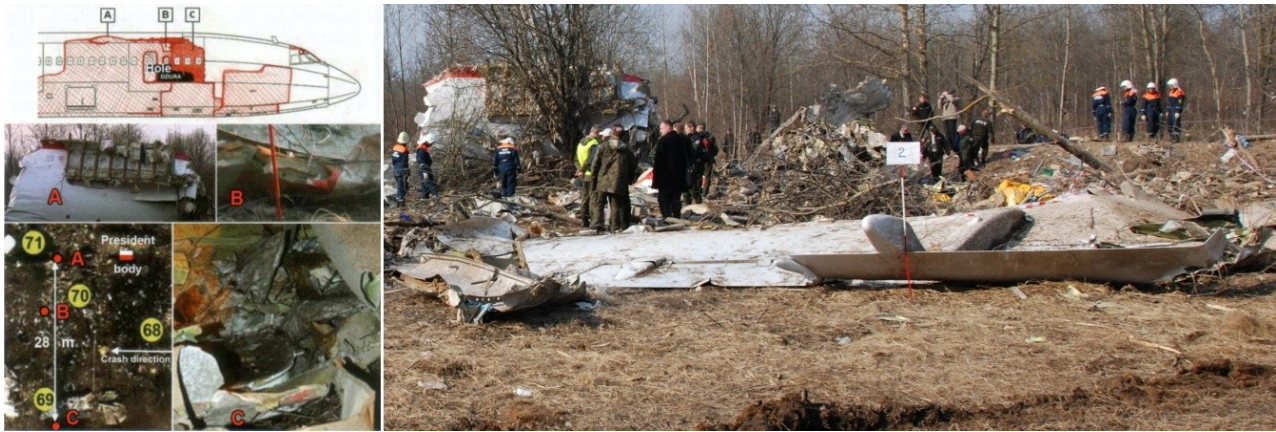
Several detailed photographs taken at the point C reveal no part resembling fuselage wall with windows, but fragments of the right wing instead.

Fig 11: No fragments of the fuselage at “point C”, just fragments of the right wing. Remains of the president's suite (“point A”) visible behind a tree.

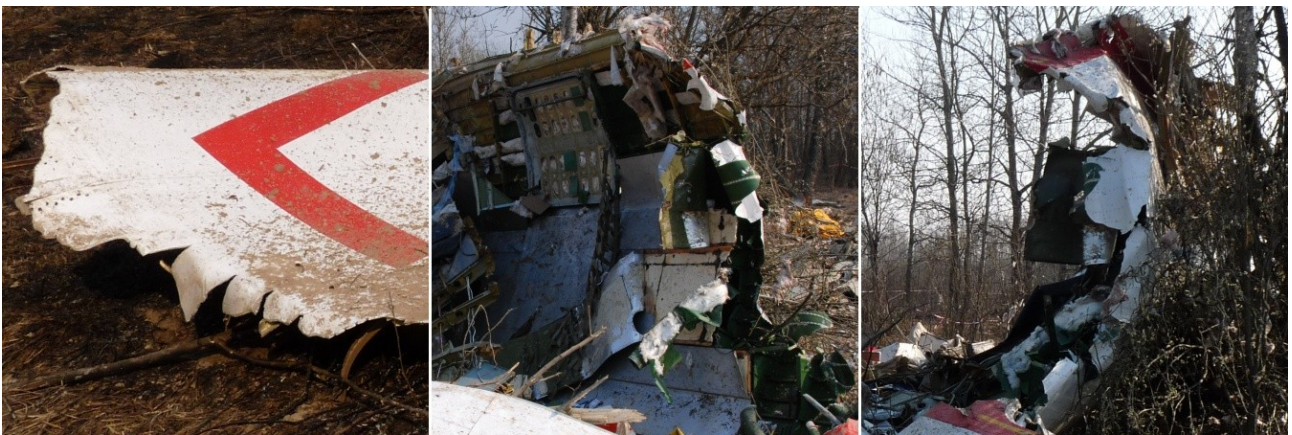
Photos show edges bent outwards as well as inwards.

*Fig 12: Edges of fragments were bent outwards as well as inwards*
