# **Vladimir Putin's Russian Government Inquiry into the Crash of The Polish Air Force One in Smolensk, Russia, April 10, 2010**

**Polish Parliamentary Committee for the investigation of  
the Tu-154M crash in Smolensk, Russia on April 10<sup>th</sup>, 2010  
under the chairmanship of Antoni Macierewicz**

**Study prepared by Kazimierz Nowaczyk, Ph.D.**

**European Parliament, Brussels, March 2015**

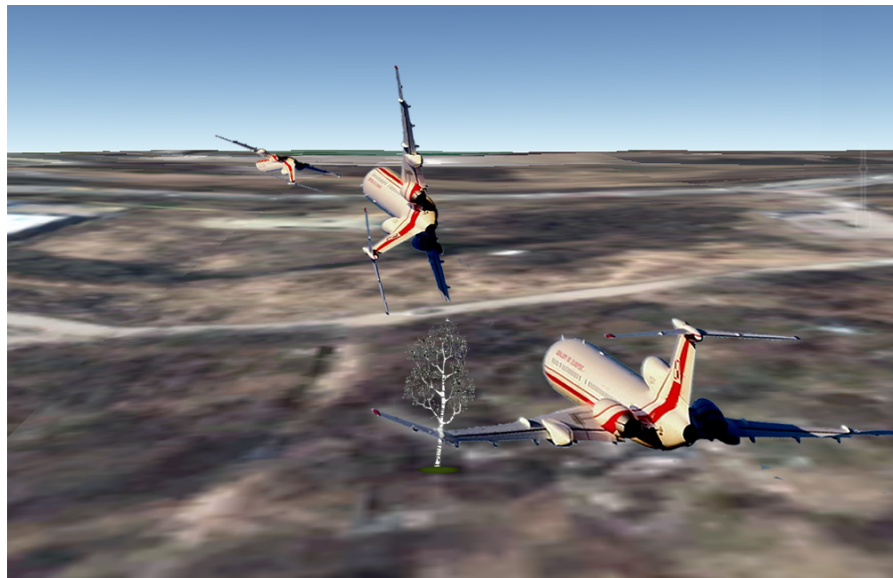
IAC ascribed full responsibility for the disaster to the Polish pilots. According to IAC, the crew did not abort descent at the minimum descent altitude established at 100 m, but rather continued descent

**Figure 2.** Visualisation of the last seconds prior to ground impact according to the IAC report (K. Nowaczyk)

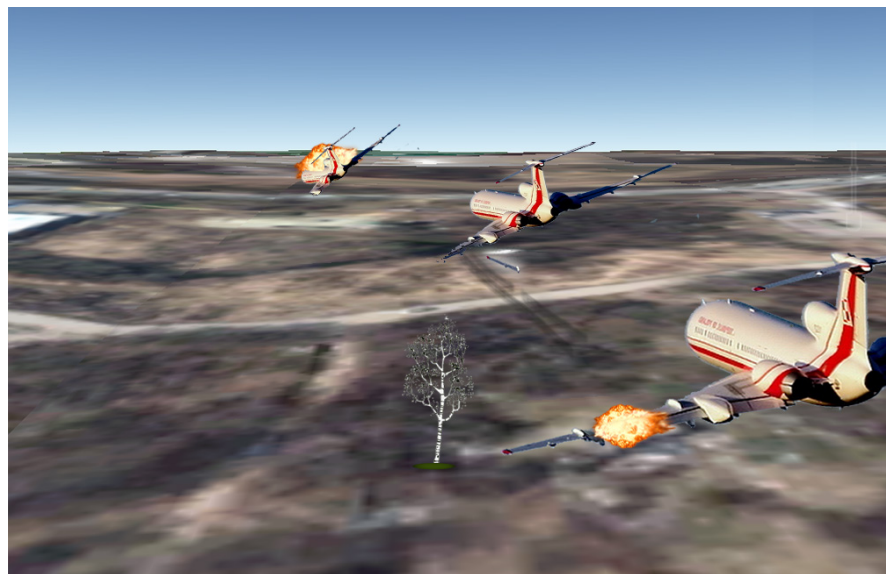
**Figure 3.** Last seconds scenario according to experts and researchers cooperating with the Parliamentary Committee. Accurate tilt to the left side of the aircraft still unknown. (K. Nowaczyk)

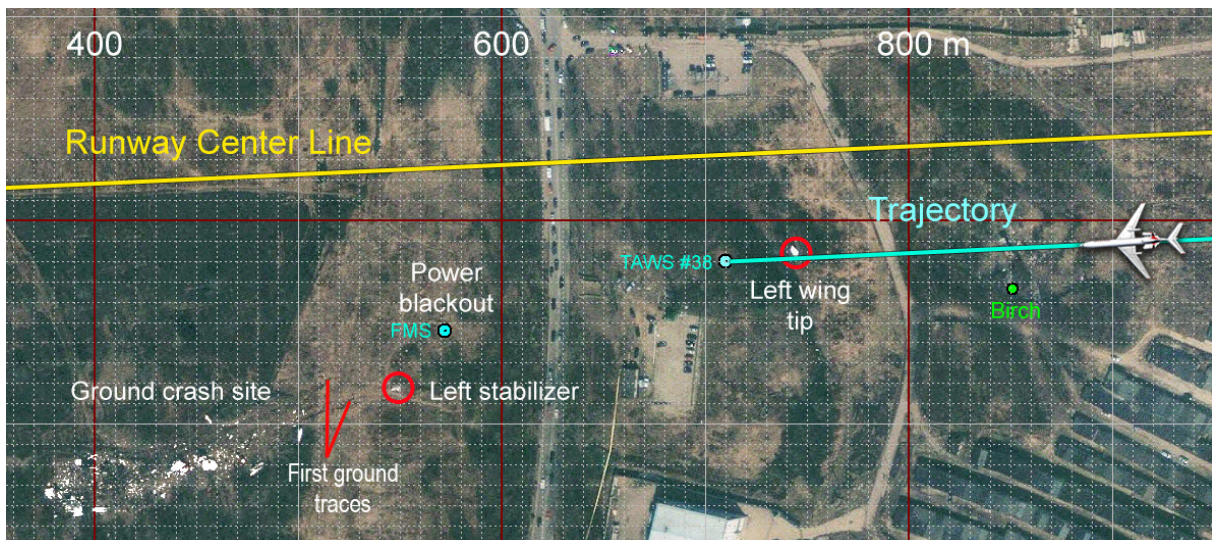
**Figure 2.** Airplane trajectory (cyan line) compared to the runway center line (yellow line). Map prepared based on IAC report (Appendix VIII), satellite picture (Appendix VI) and NTSB report (Appendix VII). FMS and TAWS #38 positions from Universal Avionics NTSB Expertise (Appendix X). Power blackout at altitude 15 m, 70 m in front of the first traces of hitting the ground.

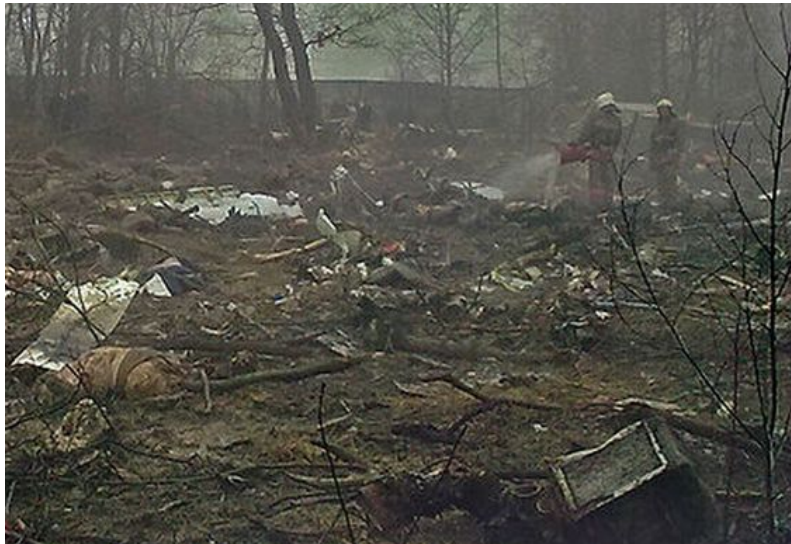
Ten minutes after the crash, airport rescue units were notified, with the first fire engines arriving on the crash scene fourteen minutes after the crash. The first medical unit arrived seventeen minutes after the crash (detailed timeline in Table 1 from the Russian report). Within minutes of the crash, Russian authorities in charge of rescue and recovery operations announced that nobody had survived. This information was immediately forwarded to Poland, even though the corpse of the President of Poland was only found four hours later. As a result of such hasty announcement, medical emergency vehicles were sent back without letting paramedics to see any victims. The rescue crew did not conduct any rescue operations and was ordered by the military officials to withdraw as all passengers died. Photo in Figure 8. shows the central part of the crash scene 57 minutes after crash.

**Figure 8.** Rescue operations at the crash site. 11:38 local time (57 minutes after the crash), April 10, 2010

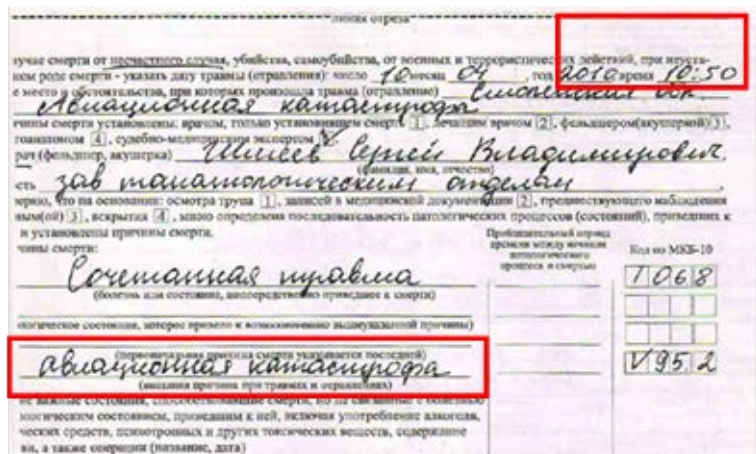
**Figure 9.** Autopsy example. Time of death 10:50 (official crash time 10:41:06). Cause of death: Aircraft catastrophe. Appendix V.

that led to the death of the particular person. However, with respect to all the victims of the Smolensk crash, the cause of death was determined as “multiple injuries.” Such approach proves that the medical examination was superficial, did not include a detailed analysis of the injuries, and there was no effort to categorise the contributions of various injuries to the deaths of individual victims. Due to unprecedented destruction of the bodies, it was not possible to collect blood and urine samples for testing of all the victims. But even in the instances when such material was collected, full range of testing was not conducted in a timely manner. Additionally, the process of collecting and protecting samples for testing was inappropriate. Some of the samples were sent for chemical and toxicology testing more than two years later. No testing was done on the clothing of the victims described as burnt or charred. Autopsy reports reflected a noteworthy departure from the medical reporting standards, including, inter alia, a uniform summary statement of the cause of death recorded with no individual details for any of the victims, as well as a uniform time of death, different from the official crash time (see example in Figure 9.)

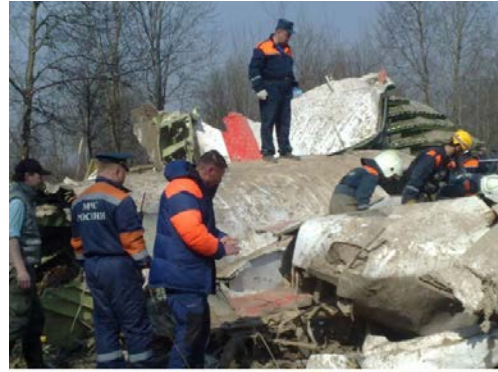
Finally, a self-evident photograph (Fig. 14) showing a large part of the fuselage at the crash site proves beyond any reasonable doubt that the fuselage must have opened midair and fallen to the ground inverted, with both side walls of the fuselage bent outwards. Consequently, the next day after the crash, both walls of the fuselage were cut off and moved away. This is clearly visible in the aerial view picture of the crash site presented in the IAC report (Fig. 15).

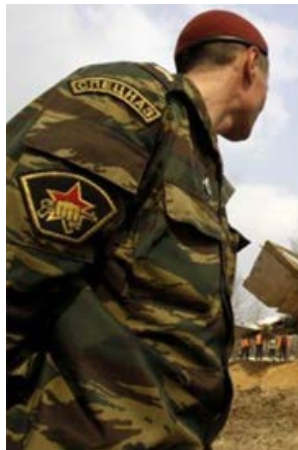
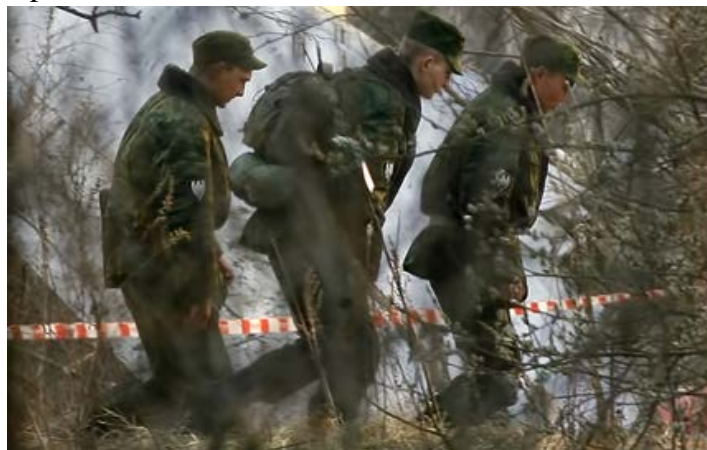
Shortly after the Tu-154M carrying the Polish president crashed in Smolensk, Spetsnaz troops (special forces) appeared on the site; soldiers from 25 branch Military Unit No. 7459 Spetsnaz MVD in Smolensk are known to have participated in bloody special operations in the North Caucasus (Fig. 16, 17). The official Russian IAC report concealed the presence of these units at the site of the tragedy.

**Figure 16-17.** From the very beginning, Spetsnaz special military unit was present at the crash site. Arrival of additional Spetsnaz (special purpose forces) personnel two days after crash (4-12-10).

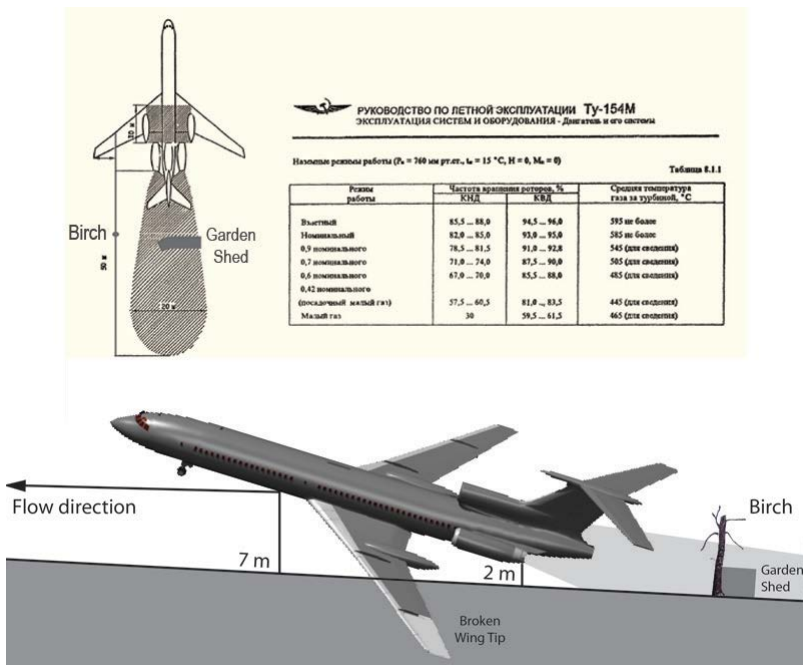
Using the digital ATM QAR copy from Moscow, it was possible to establish the actual position of the plane at 6:40:57,375 UTC time, around 30 m after the birch tree location (Fig. 24).

As seen in the figure, the left wing of the aircraft even after having supposedly lost its left tip would have been two meters underground.

**Figure 24.** Tu-154M position at 6:40:57.375 from ATM QAR digital data (Moscow, June 2011)

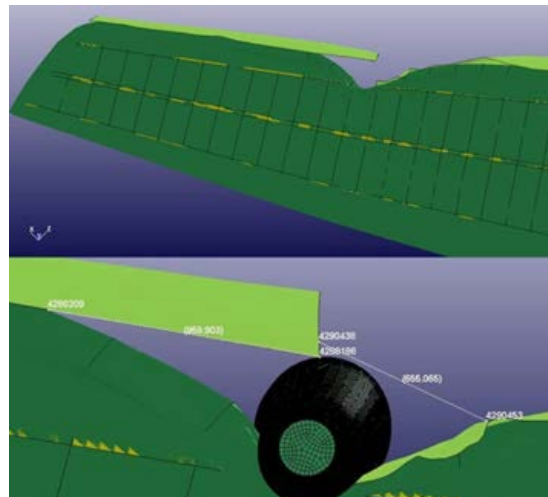
plane had hit the birch tree at the velocity 75 m/s, the wing would have cut the tree. There would only be a minor damage to the wing edge (Figure 25).

Figure 25. Prof Binienda LS-Dyna wing-birch collision simulation.
